塑膠排水浪管改良稻田排水防止稻株鐵過多及鉀銅缺失之研究¹

謝慶芳 王錦堂 林昭遠²

Effects of Constructing Corrugated Drainage Pipe Lines in the Poorly Drained Paddy Soils on Reducing Iron Toxicity and Potassium and Copper Deficiencies of Rice Plants.¹

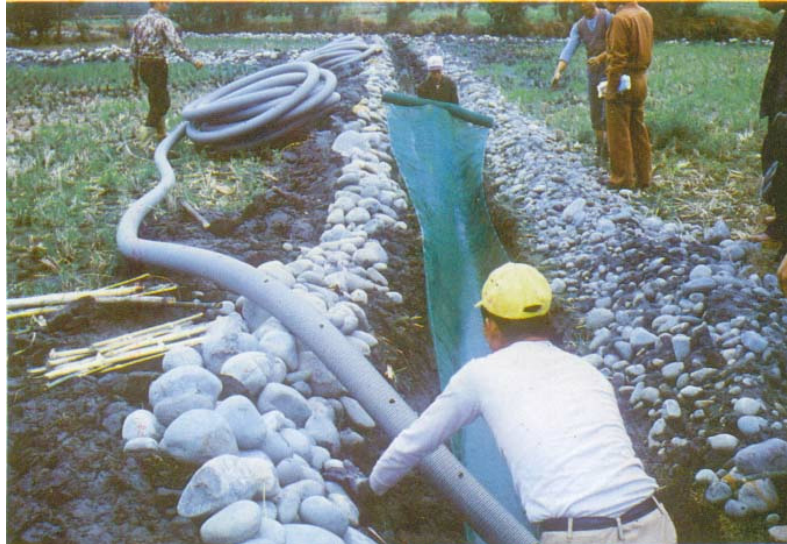
圖 1 按照適當之間隔、寬度、深度、及坡度挖好排水溝之後即開始埋設塑膠浪管
Fig. 1 An constructed underground drainage system having proper space, width, depth and gradient

本試驗是於七十年一期作在臺中縣大安鄉頂安村舉行，試驗前先15m之距離挖掘寬40cm，深60cm之小溝，按排水方向保持約1/200的坡度使排水能夠暢流無阻，即於溝底鋪一層一般尼龍網，然後鋪上長度50m之塑膠浪管(圖1)，兩邊用原地挖出之直徑約5~15cm之石頭墊緊，上面再鋪一層厚約15cm之合石，即將尼龍網拉起包起來，再填上一層厚約15cm之粗

砂，最後填上原挖出之田土，踏實，另外在每100m處之浪管連接處用水涵洞通到地面，浪管之尾端則用塑膠管通到地面，以利通氣及灌洗。

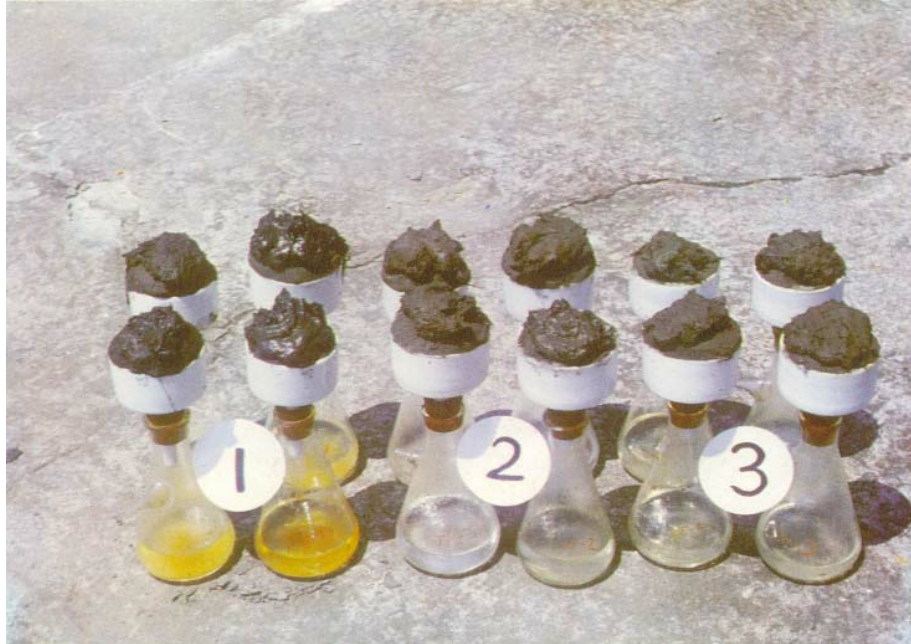
圖 2 未排水之對照區新鮮土壤之飽和抽出液呈現含有鐵化物之黃褐色，埋設塑膠浪管區及埋設塑膠浪管又施穀殼區之排水良好，新鮮土壤之飽和抽出液是透明無色。

Fig. 2 The saturation extract of the fresh soils sampled from control, drainage pi otand drainage and rice hull treated plots. It showed brown to transparent fromleft to right, respectively.

幼穗期取樣之新鮮土壤及風乾土壤經過分析結果發現排水不良小區(對照)之水溶性鐵及可萃取性鐵之含量分別為31及1.758ppm，而埋設排水浪管小區分別為4.2及858ppm，埋設浪管並施穀殼小區分別為6.2及970ppm(表1及2.2)，顯然排水區之水溶性鐵及可萃取性鐵之含量降低很多，另外新鮮土壤之飽和抽出液顏色，在排水不良之小區(對照)是呈黃褐色，顯然是因為三價鐵化物存在所引起，但在埋設浪管及堆設浪管並施穀殼區則無顏色(圖2)，以上結果證明改良排水對後，土壤中過多之鐵即可大量排掉，以減少對水稻之毒害作。另外硫酸根含量，對照區為7.54m.e./100g土壤，埋設排水浪管\並穀殼區則只有3.00及3.88m.e./100g土壤，顯然改善排水之後土壤中之硫化物含量也顯著地降低，以利於水稻之生長(表2.1)，本試驗田之硫黃含量雖然較本鄉一般酸性硫酸鹽土為低，但其含量仍相當高，可是其土壤經過風乾之後pH

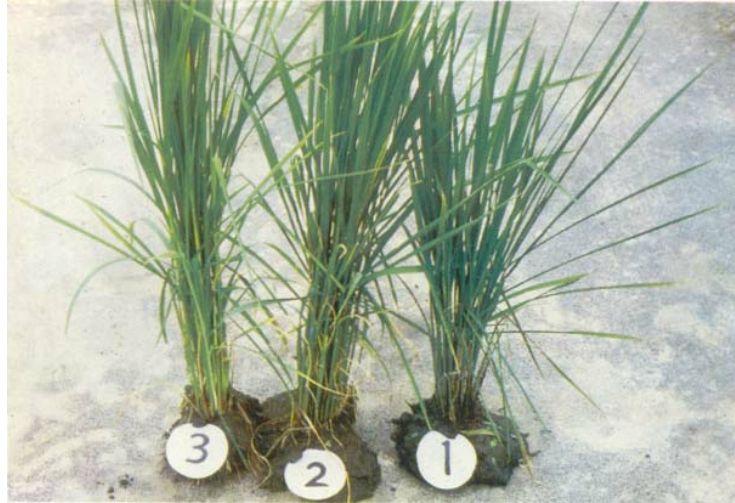
圖 3 未排水對照區之稻株明顯地矮化，而 埋設塑膠浪管區，及 埋設塑膠浪管並施穀殼區之稻株生長均正常

Fig. 3 Rice plants stunted in control and normal plants found in drainage treatment or drainage with rice hull treated plots

幼穗期水稻植物體之分析結果發現對照區稻株老葉之含鉀量(表3.1)和新葉、老葉及全株之含銅量(表3.4)均顯著地低於埋設浪管區及埋設浪管並施穀殼區，顯然已到缺乏之程度⁽¹⁶⁾，而鐵及硫則剛好相反，對照區稻株之含量顯著高於埋設浪管並施穀殼區(表3.3及3.4)，雖然硫之含量似乎未到過高之程度，但鐵之含量已達到毒害之程度⁽¹⁶⁾。從稻株之生長情形可以發現對照區之水稻呈藍綠色，植物較為矮化，老葉有許多細小之褐色斑，部分葉尖亡經枯死(圖3及4)，究竟是缺鉀症狀^(1, 16)或鐵之毒害症狀^(6, 9, 10, 12, 16)，或者是鉀銅之缺乏與鐵之過多所引起之綜合症狀，尚難做明確之結論。

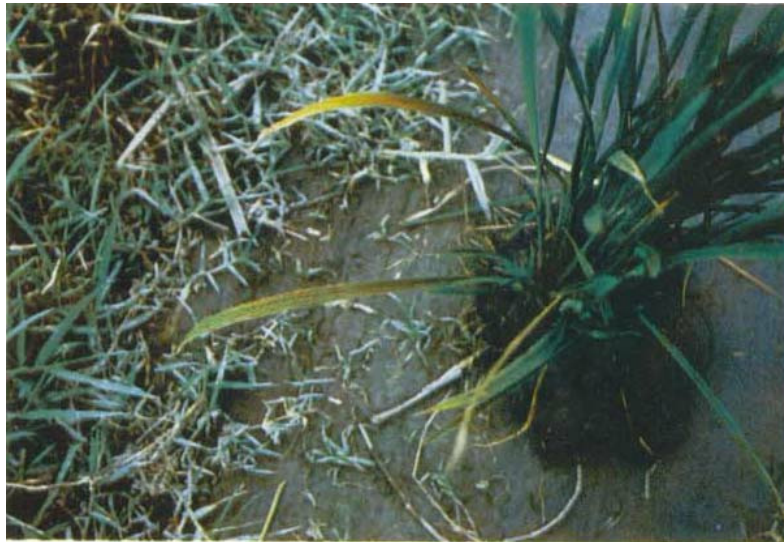
圖 4 未排水對照區稻株呈藍綠色，老葉有許多細小之褐色斑點是一種鐵過多而鉀銅缺乏所引起之毒害症狀

Fig. 4 The over accumulation of iron and deficiencies of potassium and copper in rice leaves showing greenish and lots of tiny brown spots on the old leaves of the rice plants
